COLLAPSE OF BASE SOIL AND ITS CONSEQUENCES DURING A CEMENT PLANT CONSTRUCTION

Bir Çimento Fabrikası İnşaatı Sırasında Gözlemlenen Zemin Çökmeleri ve Sonuçları

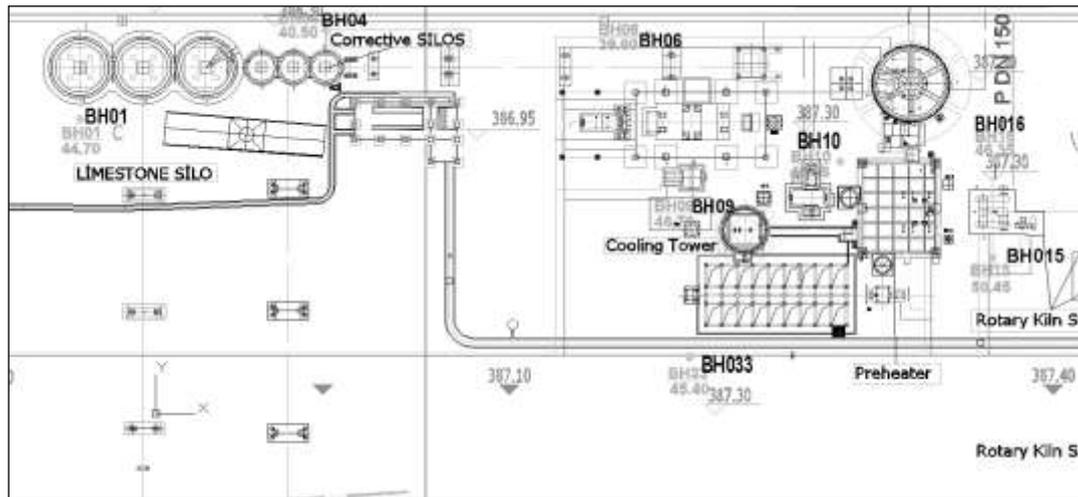
(a) Borehole locations on the west side of the construction area

The author was informed that, prior to the construction of cement plant, a company drilled 184 boreholes which were 15 to 25 meters long. The investigated area is located at a rural part of the North Azerbaijan where most of the remaining structures are single-storey houses. Consequently, there was no former information, investigation or a case history about the collapse potential of the soil in the region. As a result, care was not given to collapse potential but rather to bearing capacity issues and no experiments were carried out to investigate the collapse potential. Using the information obtained from this investigation, a design company designed the foundations and suggested 16m long piles to carry the structures to be built. Another investigation was conducted by a local company containing 10 CPT (Cone Penetration Test) tests in 45m deep boreholes and 7 CPT tests in 16-24m deep boreholes to check the design calculations.

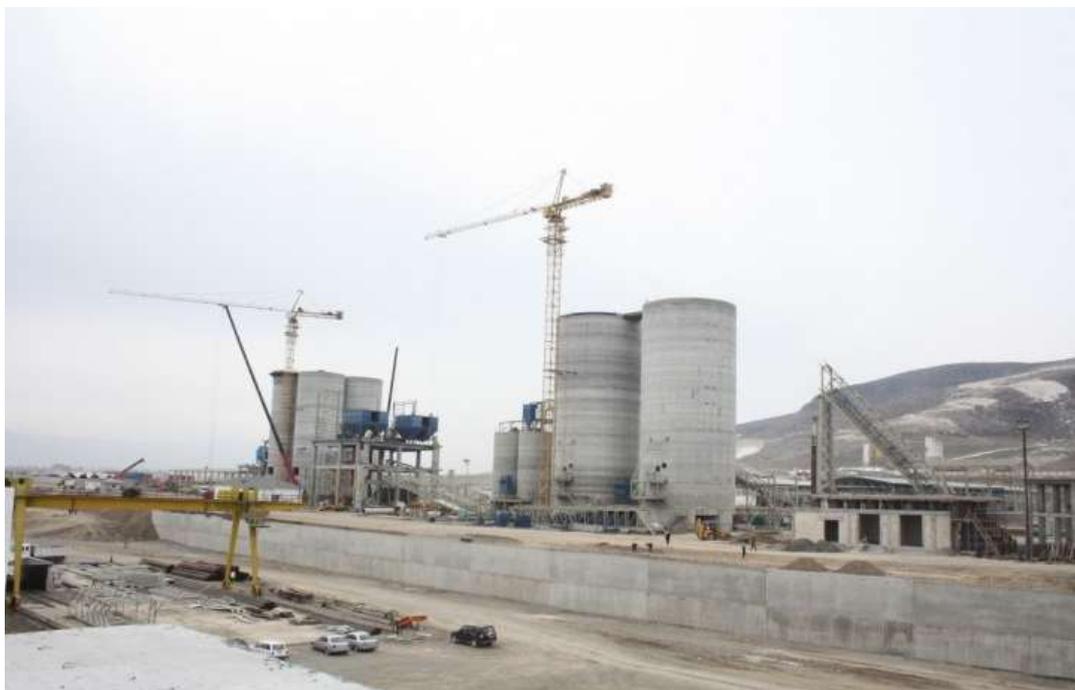
(b) A view during construction from west side of the plant
Figure 2. West side of the construction area ($\approx 850\text{m} \times 900\text{m}$)

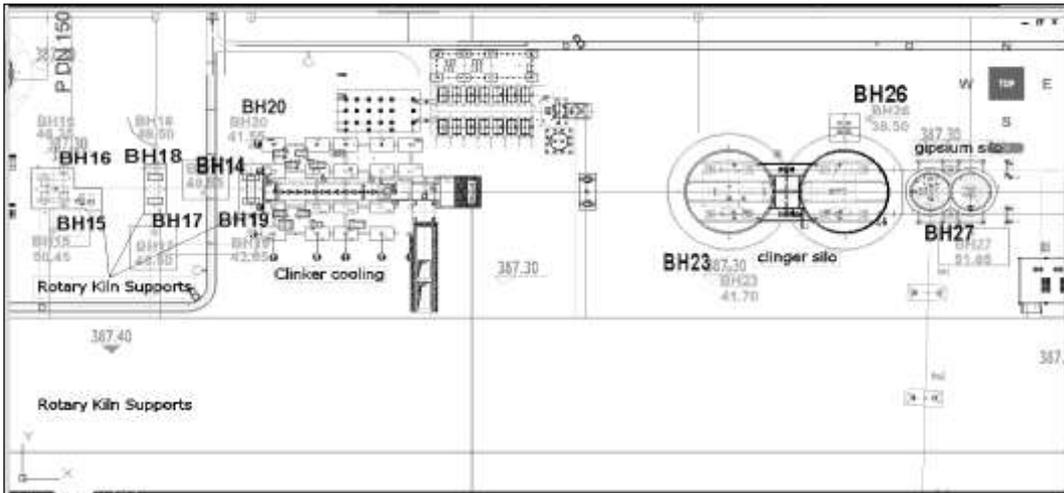
(a) Borehole locations on the east side of the construction area

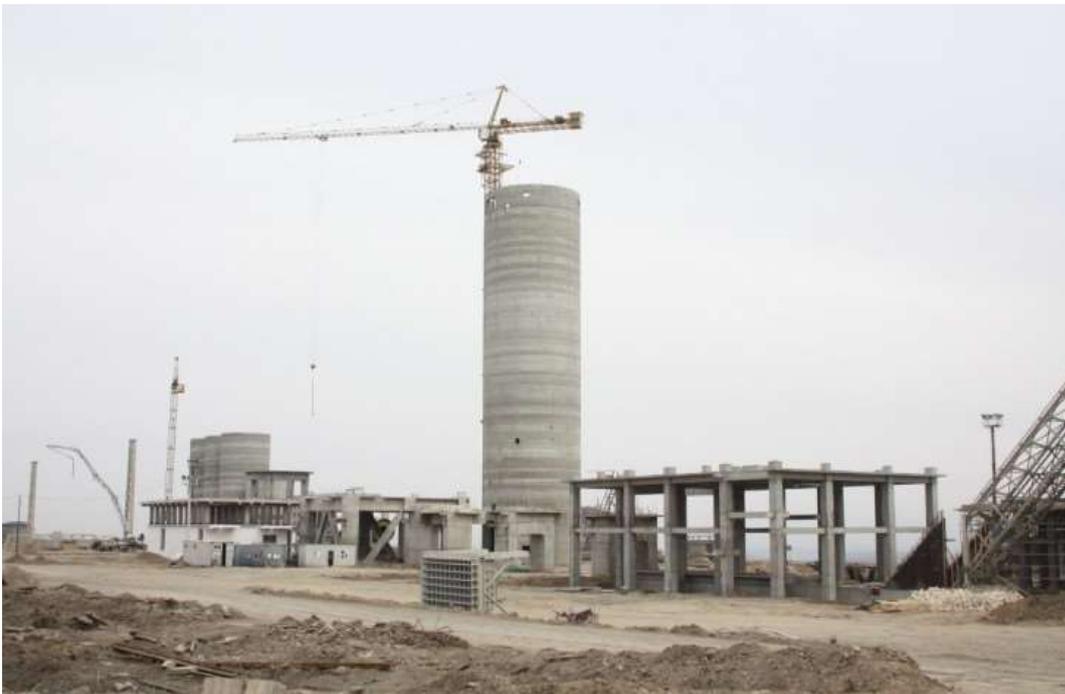
b) A view during construction from east side of the plant

Figure 3. East side of the construction area ($\approx 850\text{m} \times 550\text{m}$)

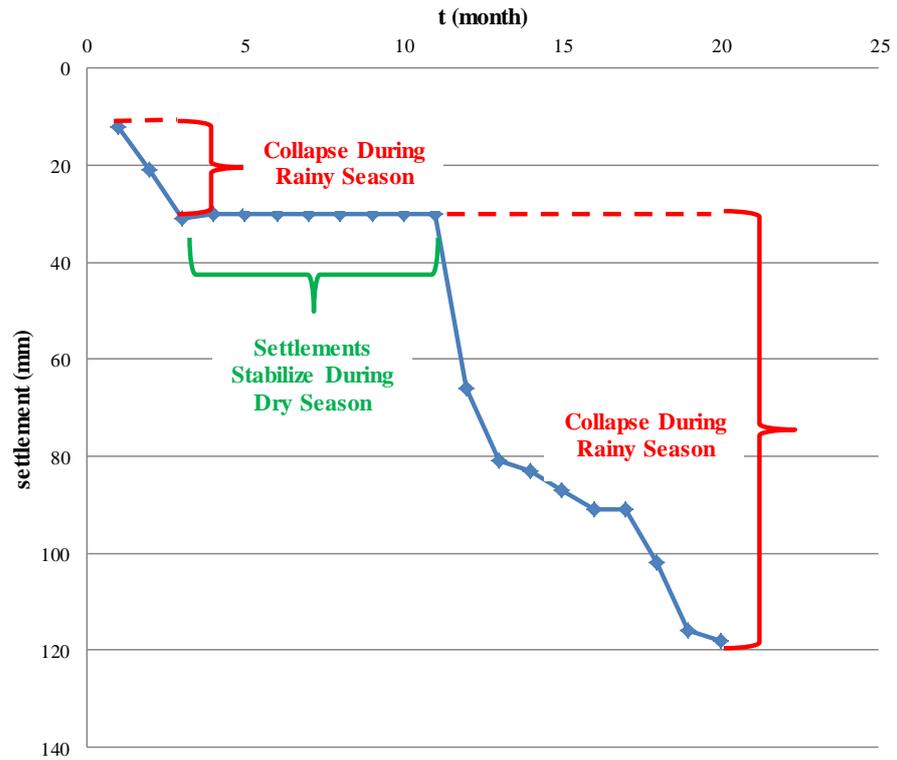
Figure 6. Time-Settlement plot for clinker silo

After tiny cracks and tiltings were observed on the built structures as an indicator of a severe settlement problem, a detailed investigation program was started based on time dependent settlement measurements recorded at different points of the site. The measurements revealed that the rate of settlements were very high during rainy seasons while it was almost flat during dry seasons indicating a very obvious collapse behavior.

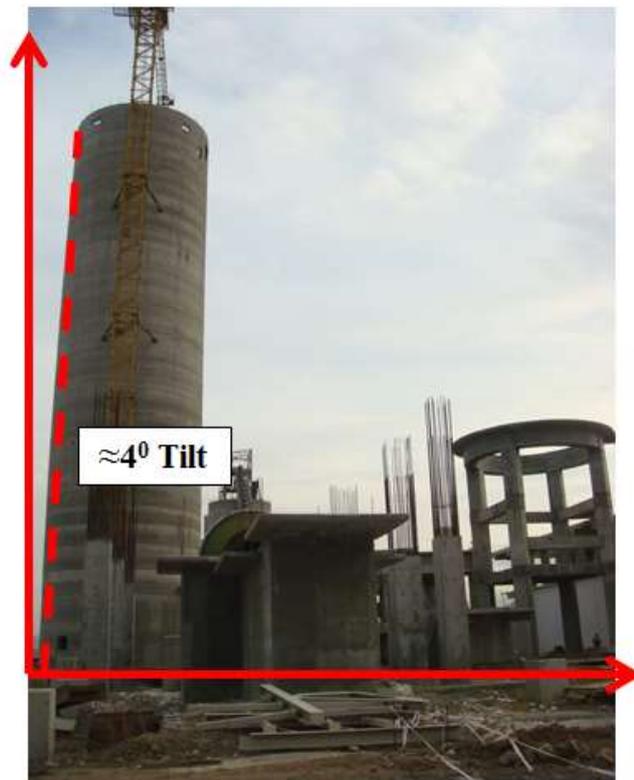
Figure 7. Tilting of clinker silo

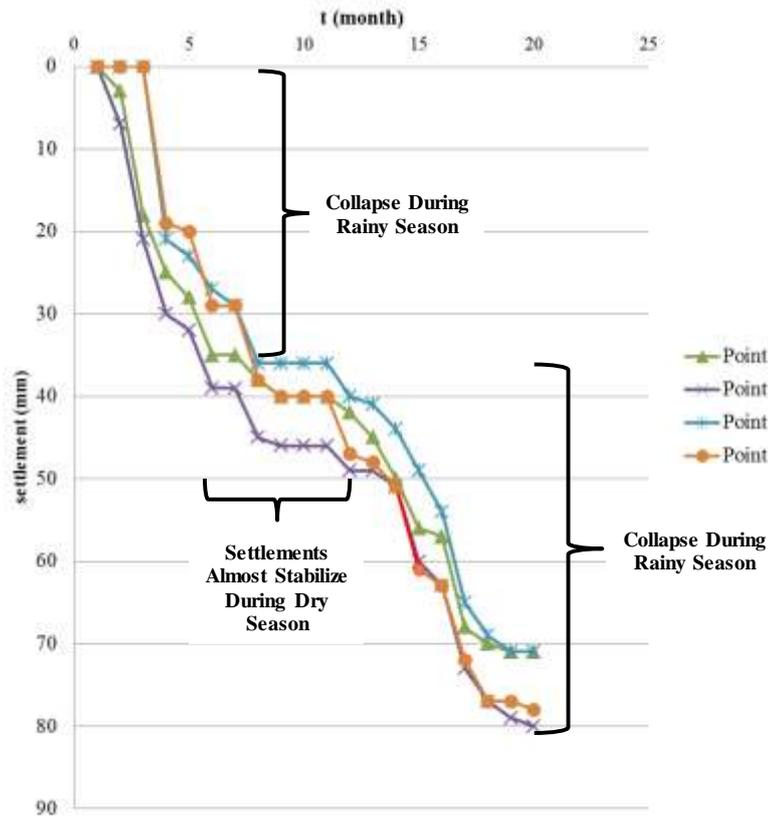
of the raw mill fan of the cement plant were measured at four corners and it was seen that the foundation had collapsed on the order of 80 mm (Fig. 8) which led to cracking of the foundation at different points (Fig. 9). Similar behavior and extensive settlements were measured at almost all important parts of the cement plant construction. The construction had been stopped for almost 2 years during which extensive site investigations were executed. The cost of underestimating the collapse probability of the base soil was tremendous since the opening of the plant was delayed for 2 years and some of the constructed facilities had to be demolished and reconstructed after soil improvement. Also 1400 piles constructed at the beginning of the project were completely sunk in to the soil and could not be used to support the structures any more resulting in another significant financial loss.

Figure 8. Settlement measurement beneath raw mill fan foundation

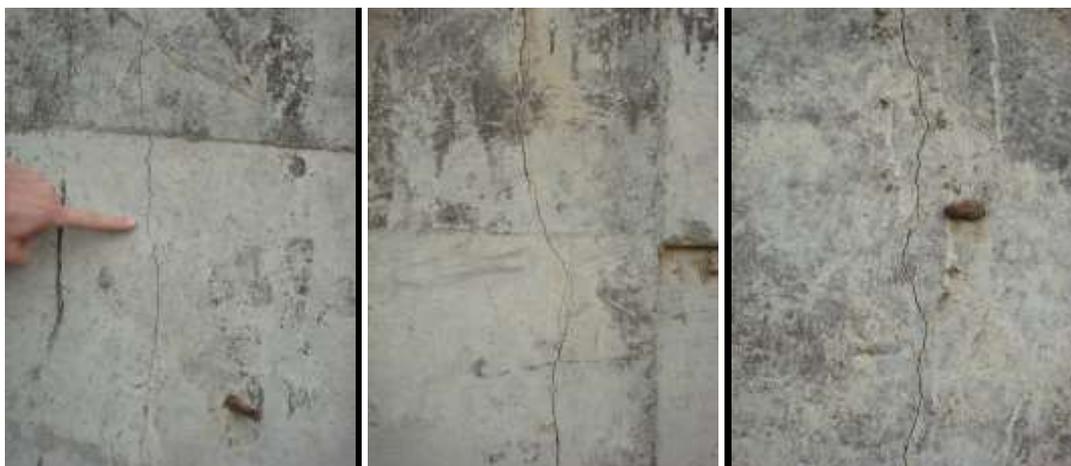
The reinforced concrete foundations were cracked due to collapse of base soil even before the construction of the structures which they were planned to carry. The settlements beneath the foundation

Figure 9. Concrete cracking in foundations due to collapse settlements
